CASE STUDY

GEOFEM

East Rand, S.Africa

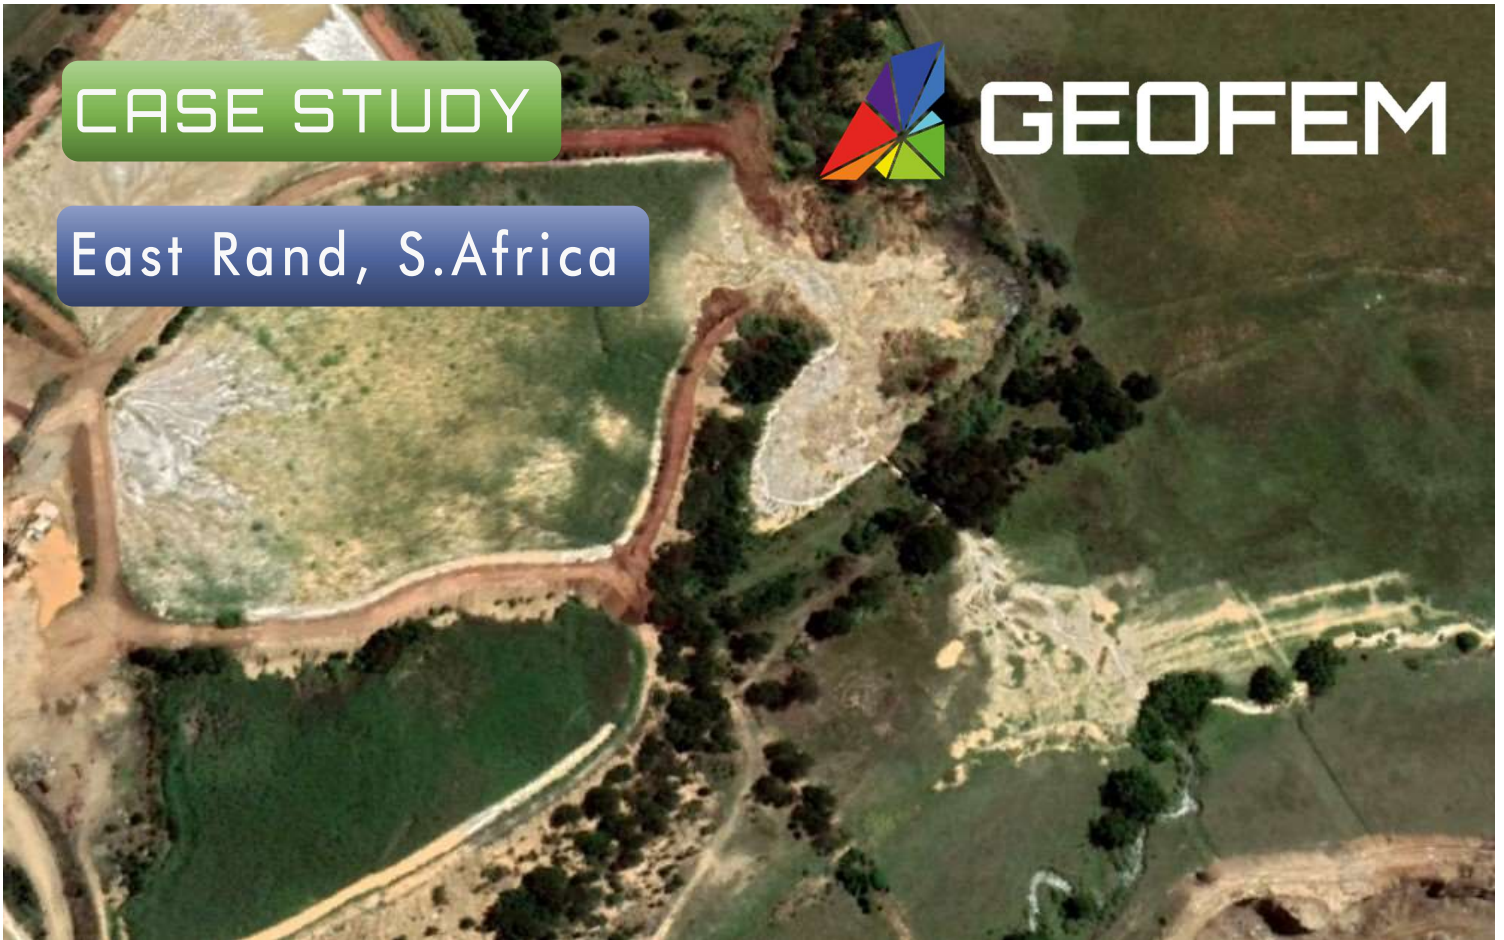
A tailings dam in the East Rand region of South Africa suffered a failure at one location in 2020. Unfortunately, this resulted in the contamination of a minor water course as visible in the bottom right of the image above. This incident provided an opportunity to establish whether the failure could have been foreseen by satellite InSAR analysis.

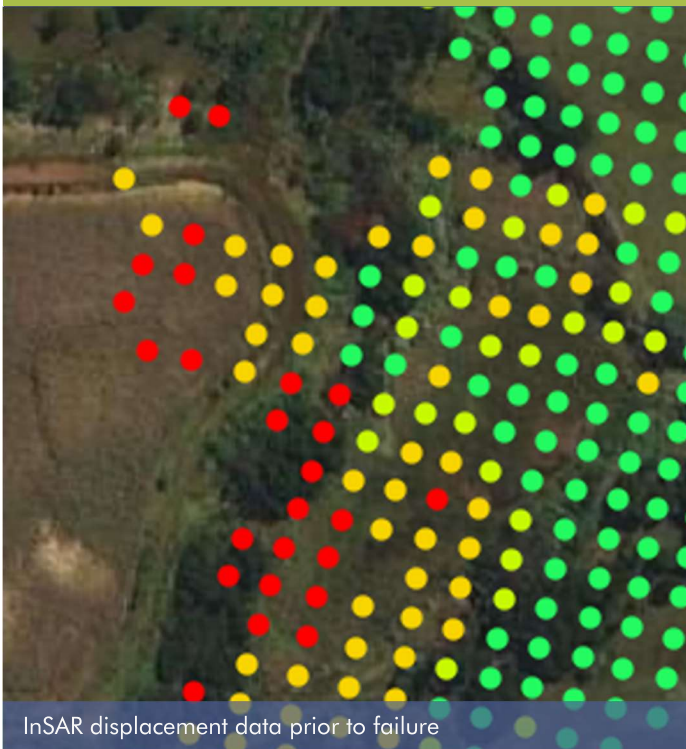
InSAR displacement data prior to failure

In one of our pilot studies of tailings dam condition surveys by InSAR there were clear signs of distress in this tailings dam in the months leading up to failure. These are denoted by the red and yellow dots in the area of the subsequent breach showing increased displacements imperceptible to the naked eye that would not have been identified by visual surveys alone.

Had regular but inexpensive and non-disruptive InSAR monitoring been undertaken, the location of instability would have been pinpointed and remedial measures undertaken to avoid the failure and pollution of the local watercourse.
